**Planning and management of sheltered space  
within Hong Kong waters**

**Audit Commission  
Hong Kong  
28 October 2024**

# PLANNING AND MANAGEMENT OF SHELTERED SPACE WITHIN HONG KONG WATERS

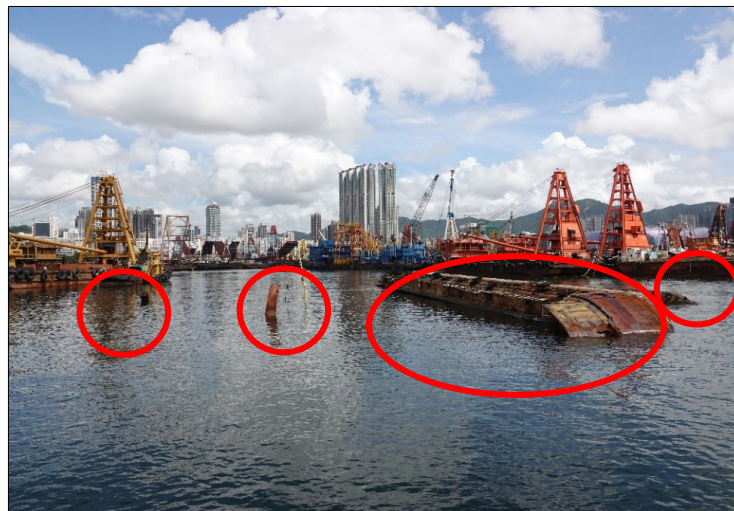
### Photograph 1

#### Examples of sunken vessels in To Kwa Wan T/S

*Remarks: COO numbers of 3 of these 4 sunken vessels could not be identified by MD*

- (j) **take proactive measures, including considering taking legal action, to recover the costs of removing the sunken vessels from the vessel owners (para. 3.22(a));**
- (k) **take urgent rectifying action in removing sunken vessels in T/Ss and S/As (para. 3.22(b));**
- (l) **consider making legislative amendment to the Merchant Shipping (Local Vessels) Ordinance to increase the penalty level on failure to comply with removal/direction notices and to introduce a fine each day during which the non-compliance continues (para. 3.22(c));**
- (m) **step up efforts in monitoring the situation of non-permitted floating structures in sheltered space, and take enforcement action in a timely manner (para. 3.28);**

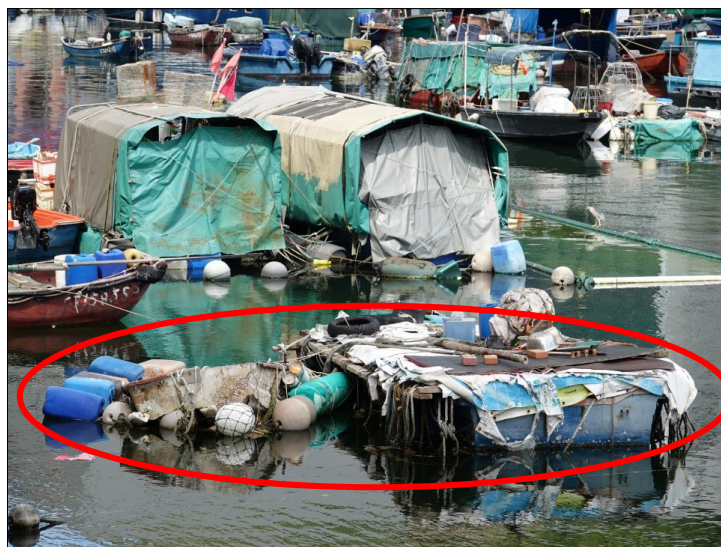
### Photograph 2

#### An example of non-permitted floating structures in Sam Ka Tsuen T/S

3.27 In view of the fact that non-permitted floating structures occupy the berthing area of T/Ss or S/As, Audit considers that MD needs to step up efforts in monitoring the situation of non-permitted floating structures in sheltered space, including sheltered space with shallow water depth (e.g. Sam Ka Tsuen T/S), and take enforcement action in a timely manner.

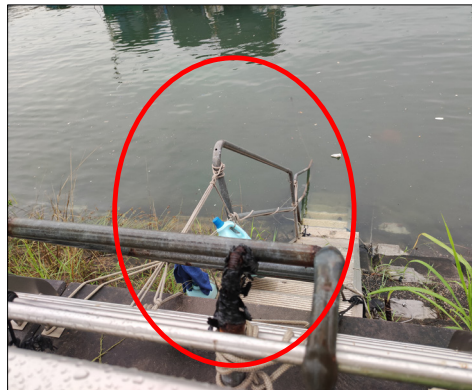
### Photograph 4

#### An example of makeshift landing at Tuen Mun T/S

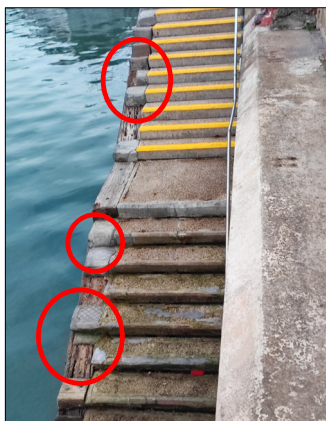
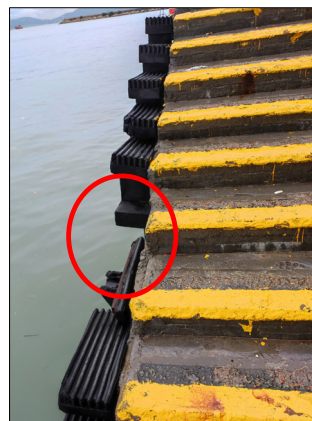
#### Examples of public landing facilities with defects

(a) Causeway Bay T/S

(b) Tuen Mun T/S

- (c) **closely monitor the issue of works orders on the rectification works for defective public landing facilities (para. 4.11(c)).**
23. **Audit has *recommended* that the Director of Water Supplies should:**
- (a) **ascertain the reasons for COO numbers recorded by the shipping water selling machine not matching those recorded in MD's list of local vessels, and enhance the functions of the shipping water selling machine (para. 4.21(a) and (b)); and**
  - (b) **investigate the possible cases of non-compliance with the Waterworks Regulations and take follow-up actions to rectify any non-compliance identified (para. 4.21(d)).**

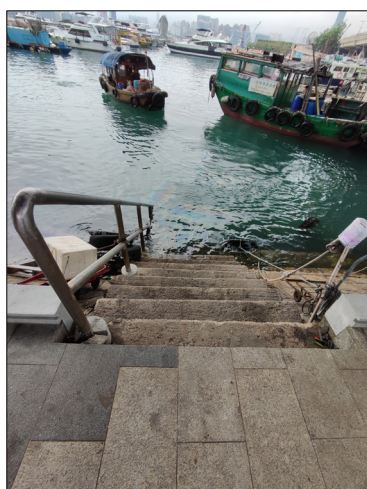
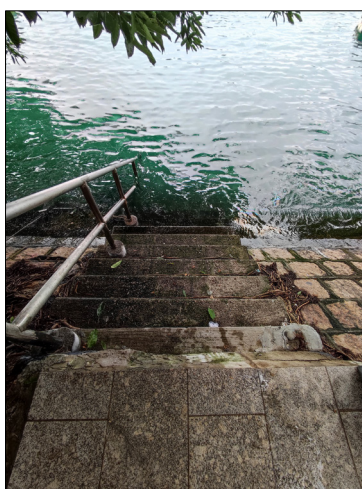
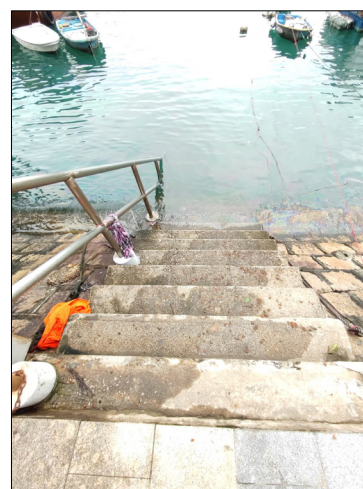
#### Concrete steps at Causeway Bay T/S

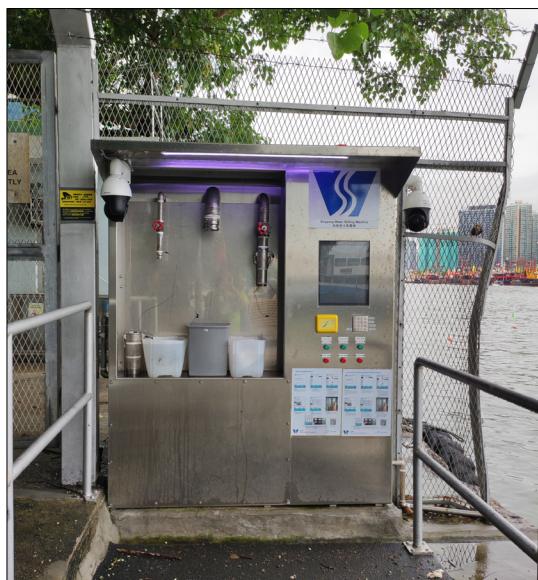
**Photograph 8**

**Shipping water selling machine at  
Tuen Mun WSK**

***Need to improve the operation of shipping water selling machine***
